THE ROCK ISLAND CLOCK TOWER, From Ordnance to Engineers

THE ROCK ISLAND
CLOCK TOWER,
From Ordnance to Engineers

ROCK ISLAND DISTRICT
U.S. ARMY CORPS OF ENGINEERS
MAY 1977

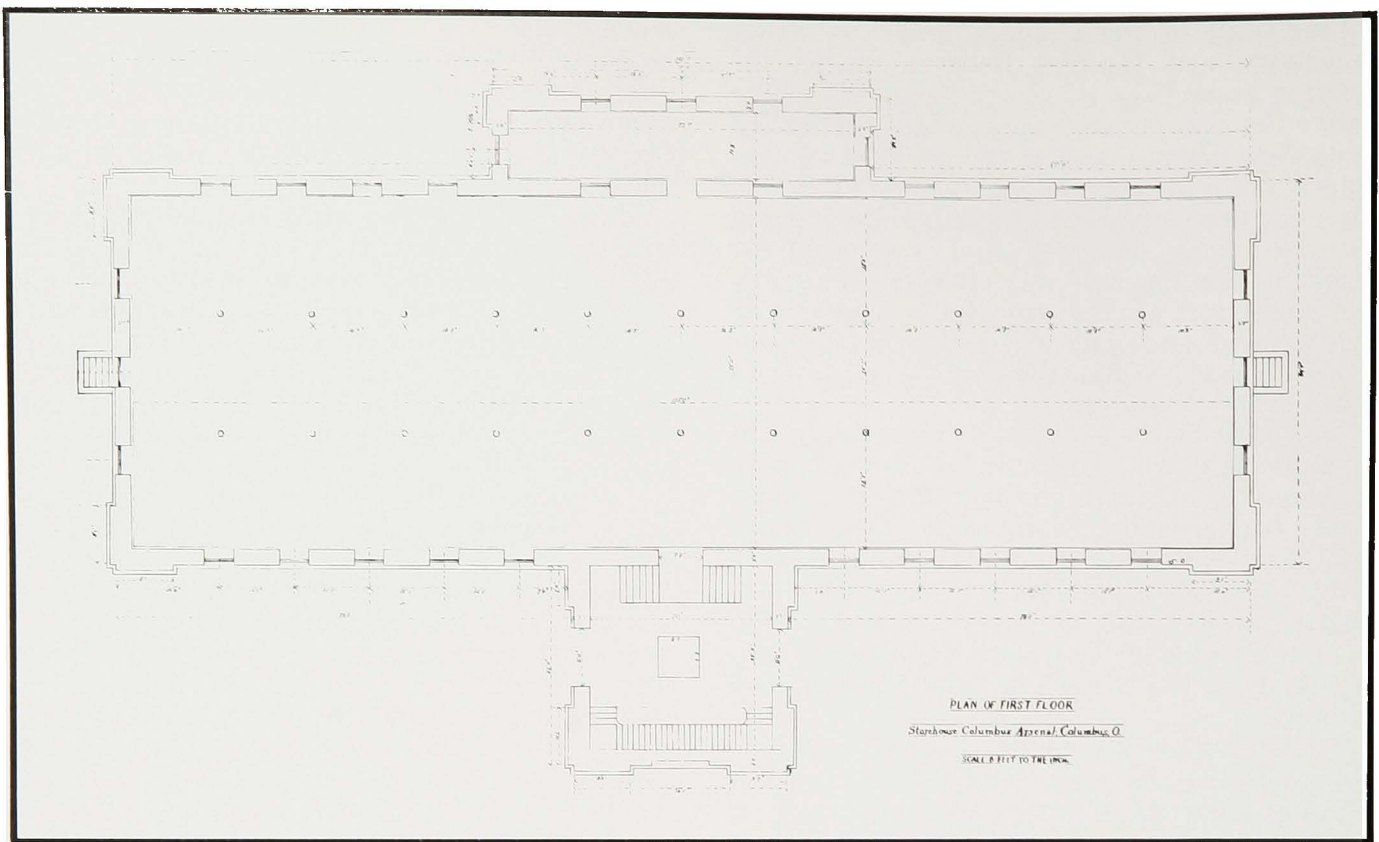
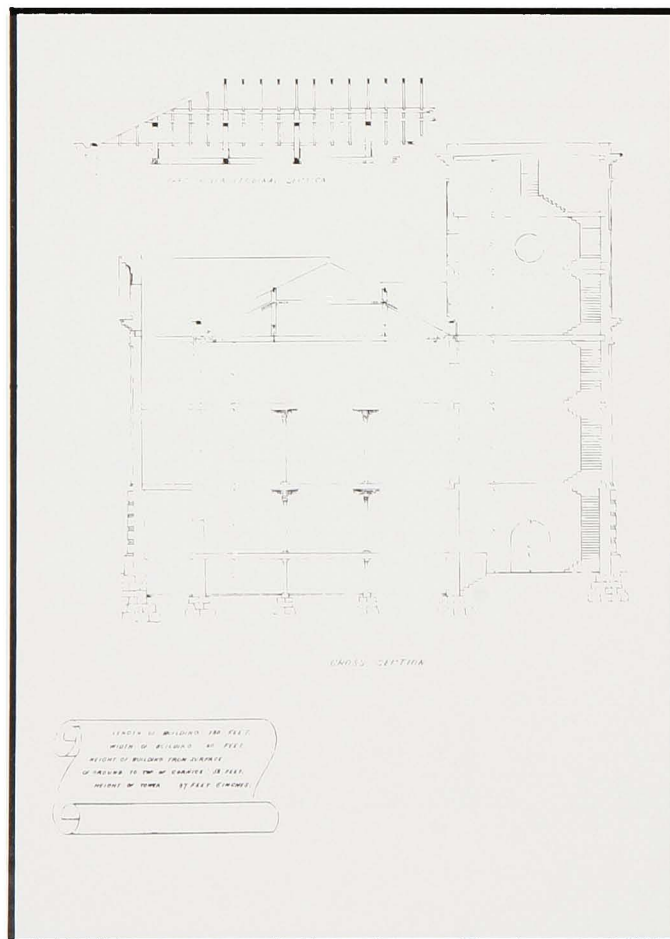
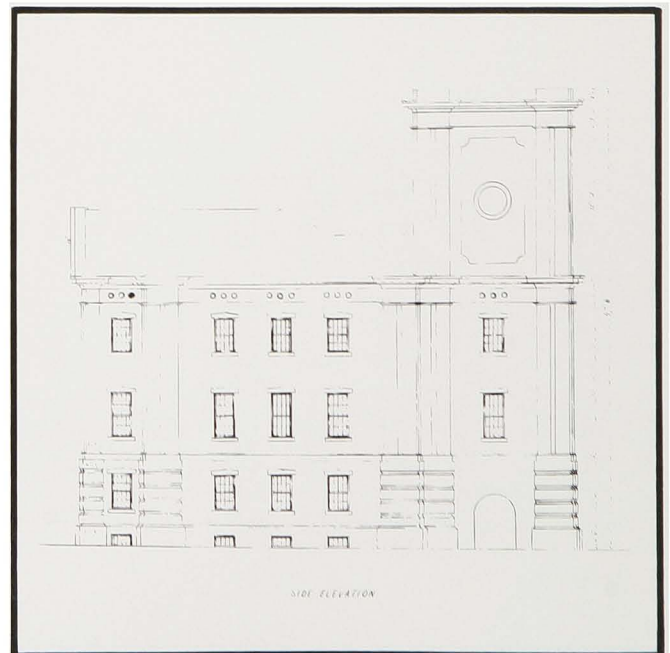
Fig. 6. Above. Top view of Storehouse A, Columbus Arsenal.

Fig. 7. Left. Structural view, Storehouse A, Columbus Arsenal.

Fig. 8. Bottom. Side view, Storehouse A, Columbus Arsenal.

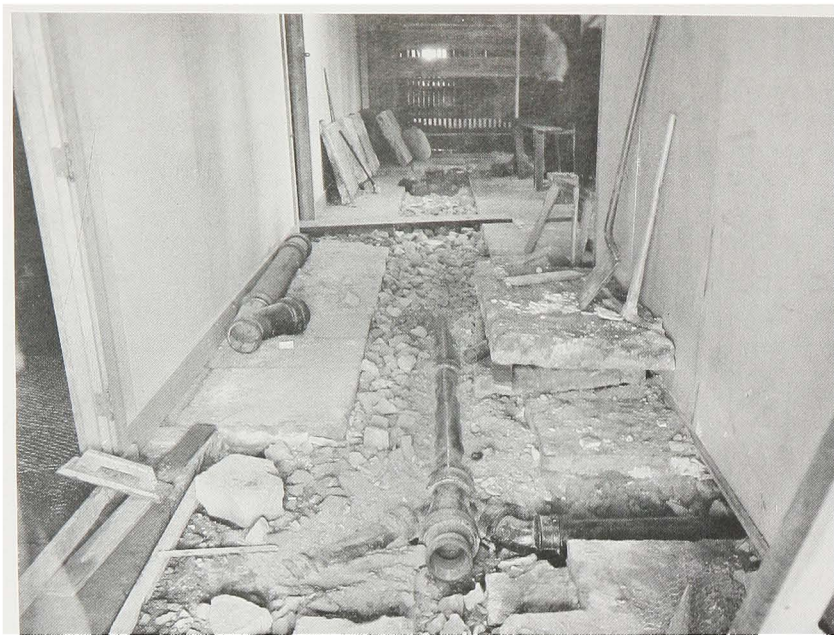
Fig. 12. The cast iron drain system beneath the Clock Tower Building, exposed during remodeling.

Major Kingsbury to begin work on the foundation on April 6. During the next two weeks workmen installed a system of drains running under the building to the river. Figure 12 shows the drains uncovered during renovation of the building in 1934. Workmen also finished the concrete work and leveling-up preparatory to beginning the stonework.⁴¹

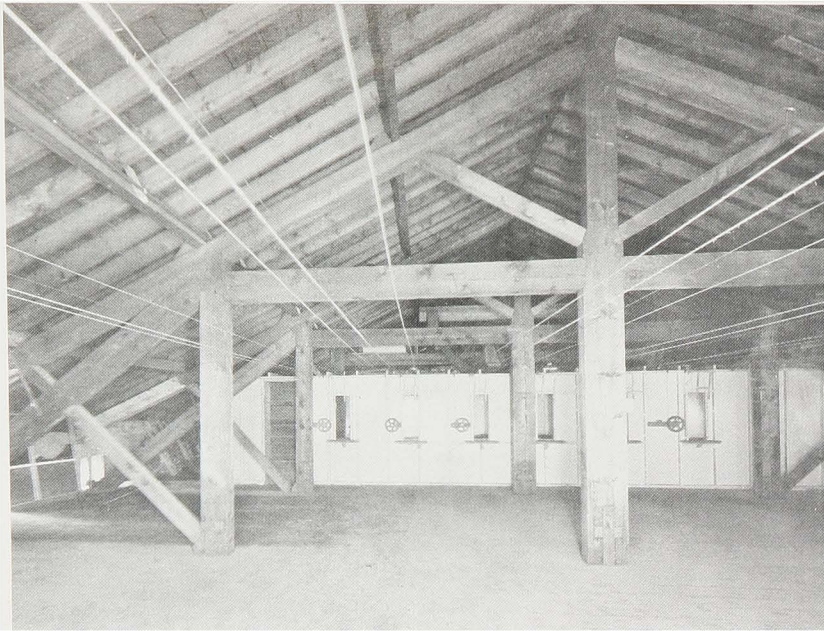
Fig. 13. Roof trusses in the attic of the Clock Tower Building.

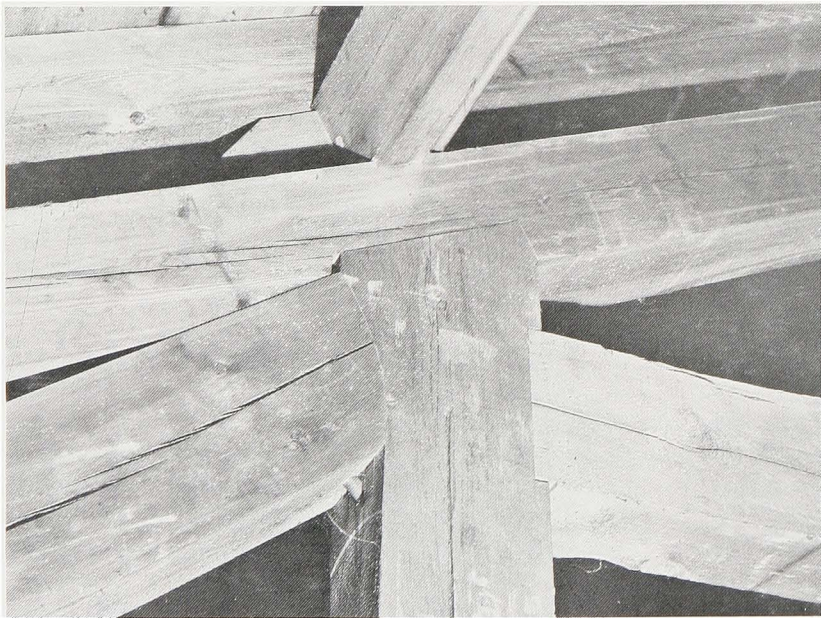
Fig. 14. Close-up view of wood joints in the truss system of the Clock Tower Building.

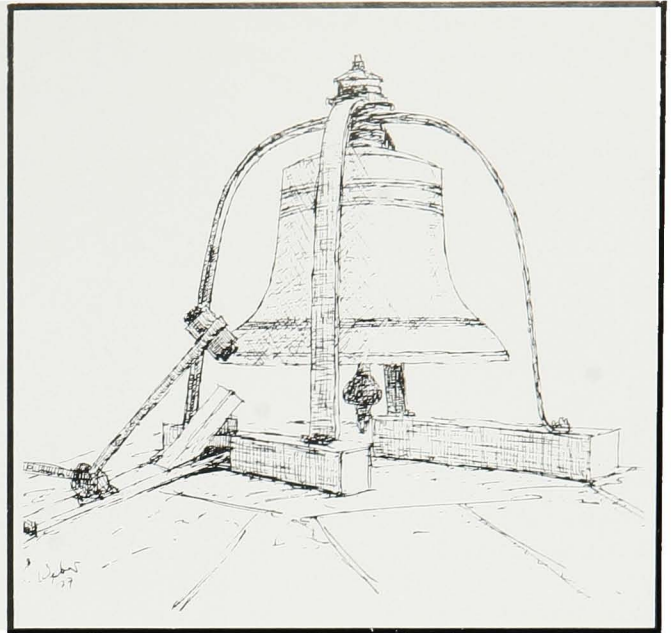
Fig. 16. Above, right. The bell and hammer mechanism on the roof of the Clock Tower Building.

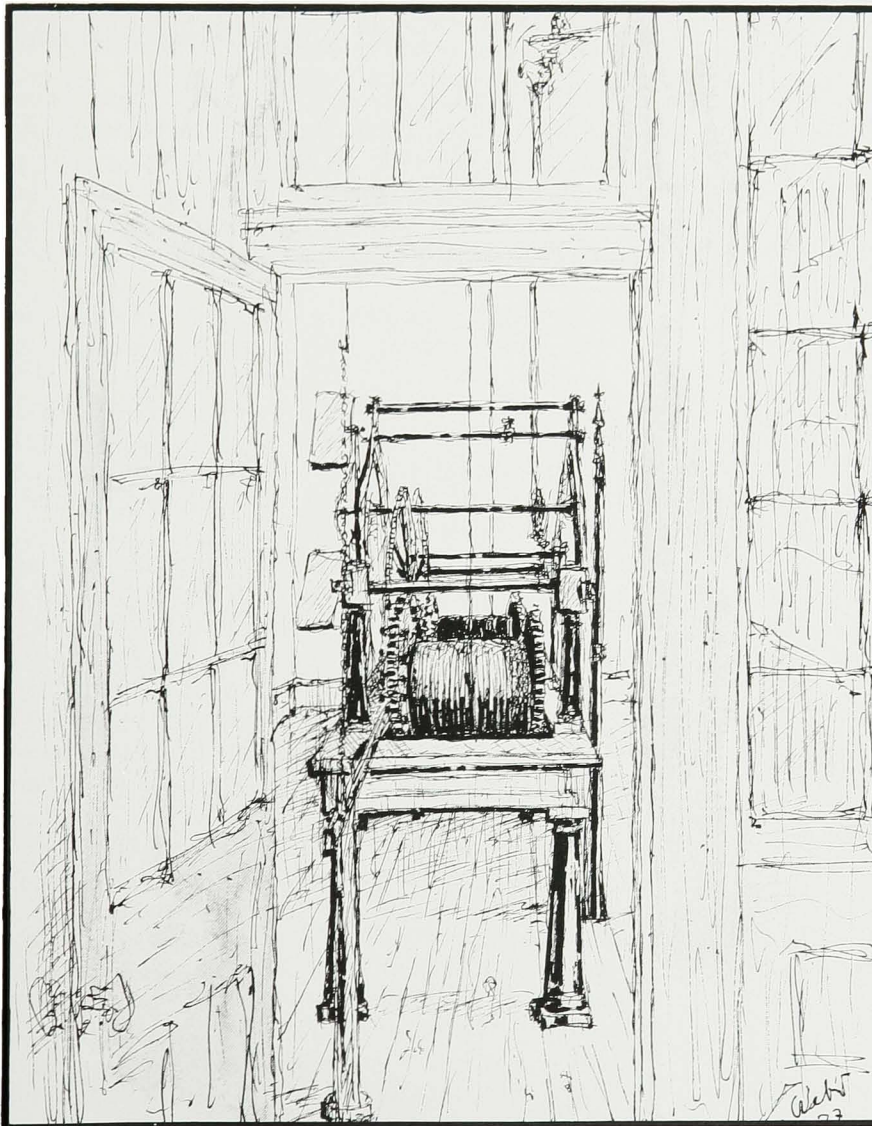
Fig. 17. The main clockworks on the sixth floor of the tower, installed in 1868. The works are enclosed by wood and glass partitions.

The time main wheel 3 feet in diameter revolves once in 12 hours. It has the hours painted on its face and a pointer denoting the hour of the day. The second wheel is 27" in diameter and revolves every hour. Minutes are painted on its face with a pointer denoting the minute of the hour. The second wheel also has a lifting pin attached to unlock the striking mechanism. The escape wheel, 8½" in diameter, revolves in 3 minutes and has the seconds pointed off. This arrangement of wheels and numbers precluded the necessity of any dial work on the movement.

The escape wheel has 30 special pins of a shape designed by Mr. Hotchkiss to prevent oil being attracted to the wheel. This leaves the pins dry and solves one of the main problems of pin escapements. The pallets are of agate, with both pins and pallets having a high polish.

The main strike wheel has 32 steel rollers for raising the hammer. All of the wheels in the works are made of bronze (gun metal); the journals or bearings are bossed with the same metal. The pinions are made of steel, while the wheels used for winding the clock are of engine-cut and polished iron.⁷¹

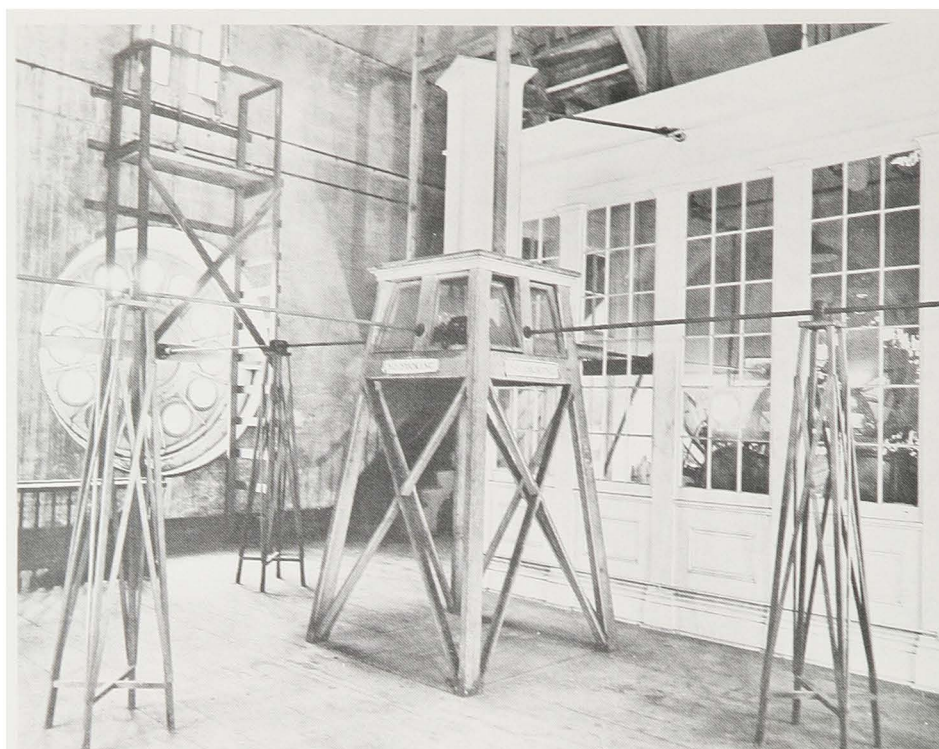
Fig. 18. The arrangement of gears from the clockworks to the four clock faces.

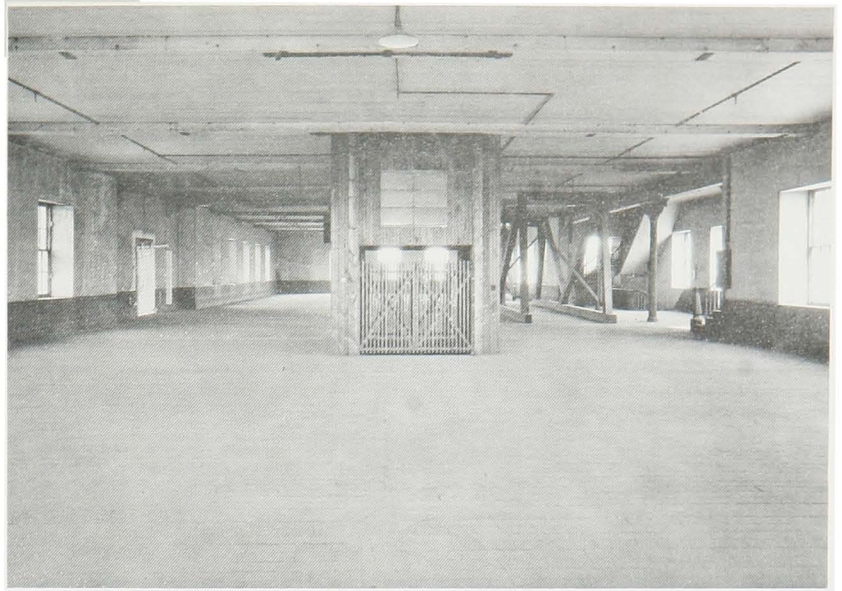
Fig. 19. Original white oak flooring on the third floor of the Clock Tower Building, prior to resurfacing.

In spite of the fact that the Clock Tower Building was now crowded with an assortment of offices, resurfacing of the old oak floors could not be put off. Many of the boards were loose, many of them had cracked and splintered, many were uneven due to sagging joists. They were difficult to keep clean and sanitary, and required frequent mopping.

Laying the floor covering was a several-step job. The old floor (See Fig. 19) of 1" by 5" oak boards had to be leveled, the cracks filled and patched with tin sheet, and loose boards nailed down. Over the whole surface a light woven wire mesh was laid down and nailed, then sealed to the boards with a sprayed coat of asphalt cement. On this, screeds of 1" by $\frac{3}{8}$ " wood were set level at ten to fifteen feet apart. A plastic mortar was then filled in between the screeds and leveled. (See Fig. 20.) After this base had cured for 4 days, a coat of asphalt cement was applied by trowel, and the 9" square tiles laid in a checkerboard pattern.

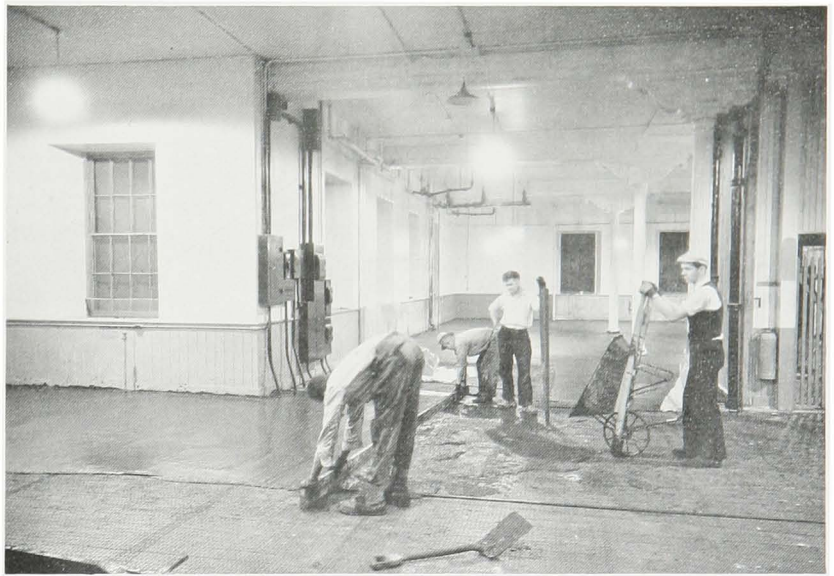
Fig. 20. Plastic mortar being placed between wooden screeds during resurfacing of the third floor in 1935.
